# Manhole Inspection Summary

Manhole # S41E\_\_010MH

Insp Date: **5/22/08 11:53 AM**

**Location** Address: **rear 11 lombard st**

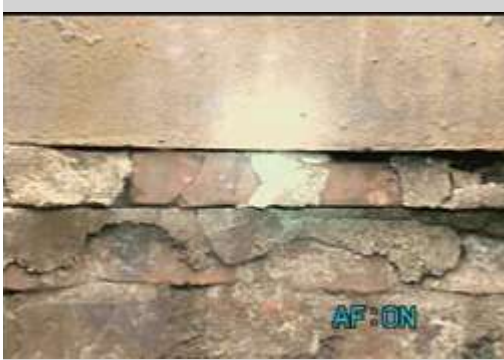
Defect 1

Condition: ☐ Sound ☒ **Cracked** ☐ Root Intrusion ☒ **Loose Brick** ☐ Deteriorated

chimney loose bricks cracked

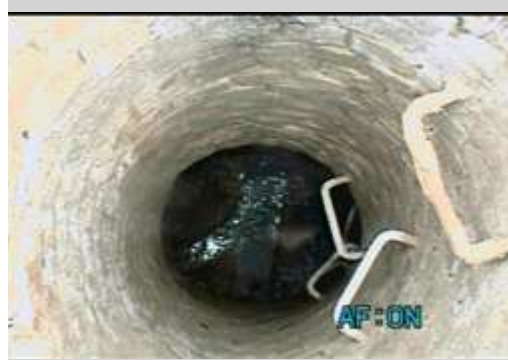
Defect 2

Count: **7** Missing: **0** ☒ **Corroded**

corroded steps
